Re: August 2017 Monthly Progress Report  
Administrative Settlement Agreement and Order on Consent for Removal Action  
U.S. EPA Region 10 Docket No. CERCLA 10-2009-0255  
Gasco Sediments Site within the Portland Harbor Superfund Site

Attachment A Monthly Visual Monitoring Report for Pilot Cap Vicinity

# Visual Observations Log Form

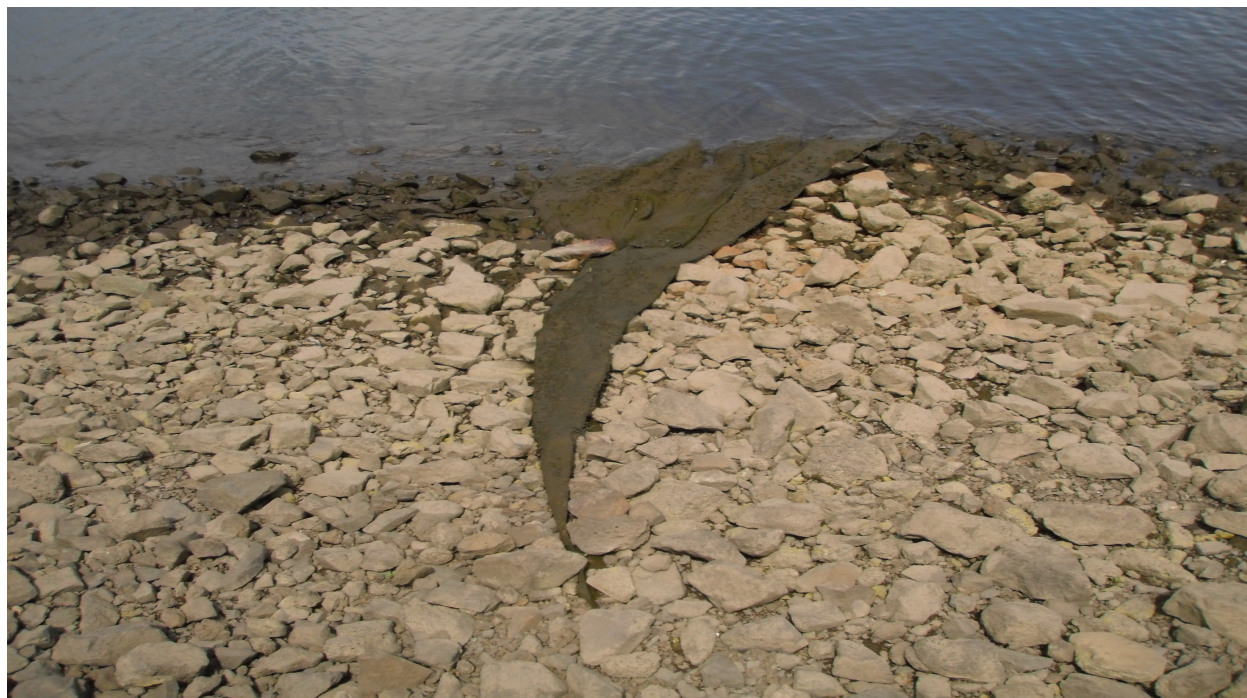
**Photo 1**

Exposed organo-clay mat material segments were observed at the current river levels. A segment 5 feet in length is exposed approximately 10 feet landward of the water's edge, near the lateral mid-point of the cap area. A 12-foot section is exposed shoreward of the water's edge, perpendicular to the shoreline at the upriver boundary of the cap area (Photo 1). A section of organo-clay mat material measuring 40 feet in length is exposed near the downriver extent of the cap at the water's edge.

**Mat material visible at the upriver extent of the cap area (8/23/2017)**

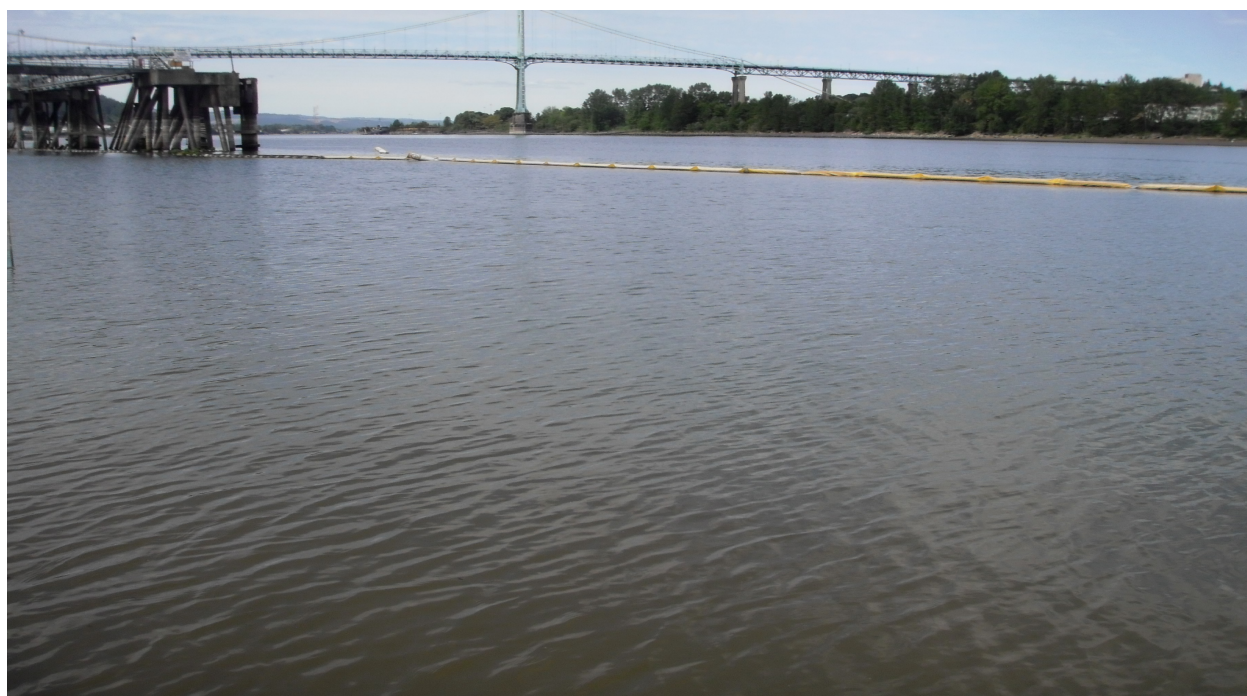
**Photo 2**

During the observation, the FMM containment boom was placed across the cap area from the ship dock to the upriver dolphin. Two buoys that identify the cap area to mariners are in place as installed, but the buoys are not in an upright position due to extremely low water levels. The positions of the FMM oil boom and warning buoys are shown in Photo 2.

**FAMM Oil Boom Placement and Mariner Warning Buoys at Pilot Cap Area (8/23/2017)**

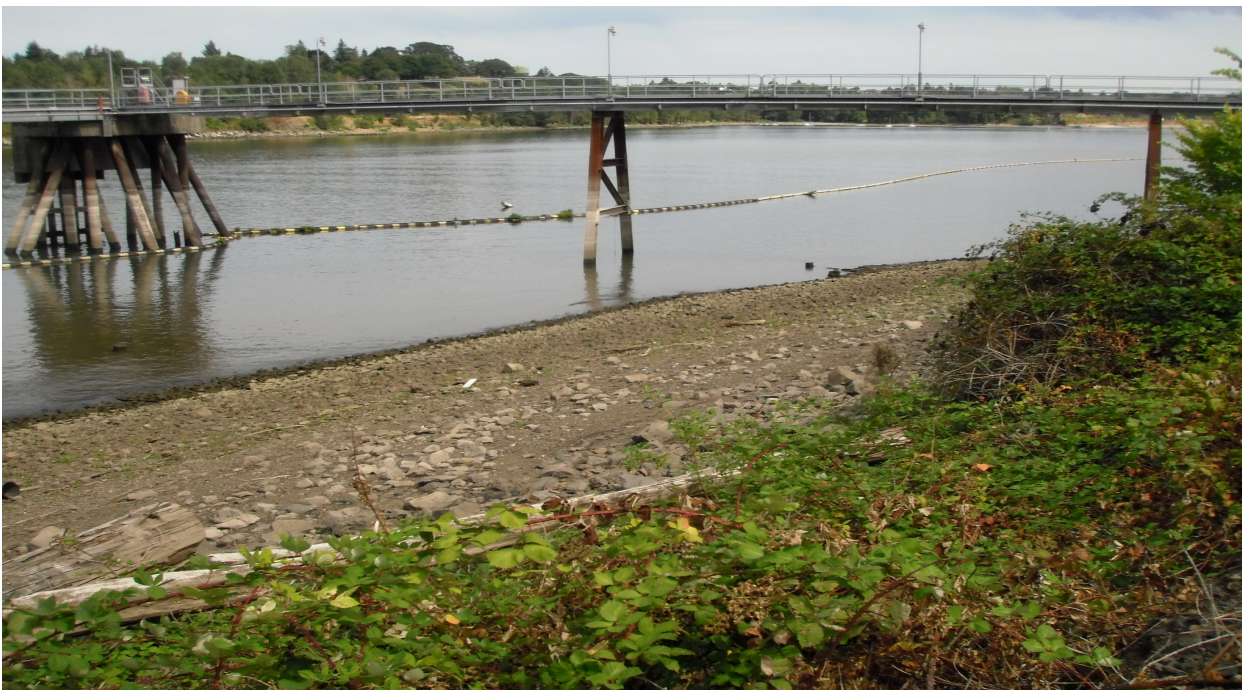
No sheen is evident in or around the cap area. Photo 3 shows the water surface and shoreline immediately downriver of the sediment cap.

**Photo 3**  
**Conditions Immediately Downriver of Cap Area (8/23/17)**
